# Technical *Info*

## Modification to the tensioning technology in the Ford 2.5 diesel (CT1055/ CT 1054)

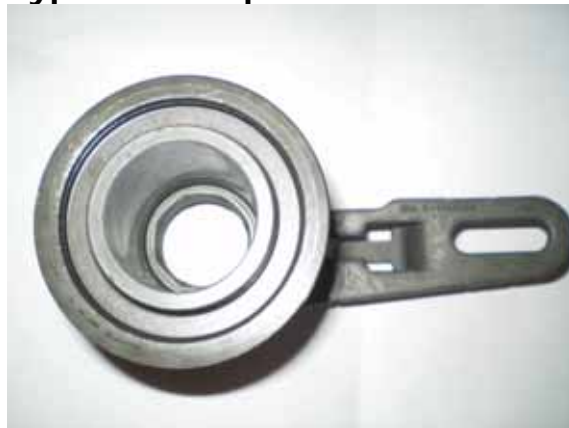
Fig. 1

The idler pulley included in the kit for the type delivered is different to the one installed in the vehicle.

Type to be replaced

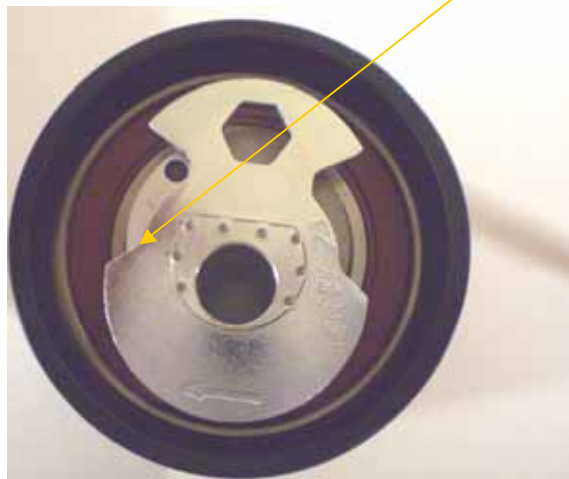
Fig. 2

New tension pulley technology  
Target tension (1)

The new type is a semi-automatic tension pulley which is installed centrally in place of the manual tensioner. Following installation of the timing belt, as normal, the tension is adjusted on the disc on the front by turning it in the direction of the arrow using an Allen key. Please note, the semicircular dot marking must be correctly aligned with the bottom edge (1) of the recess.
