Technical *Info*

Failure of the belt drive as a result of the tension pulley breaking off after breakage of stud bolt CT 1028 K2/K3/K4, CT 1051 K1/K2 (VW/Audi TDI PD 1.9/2.0 L)

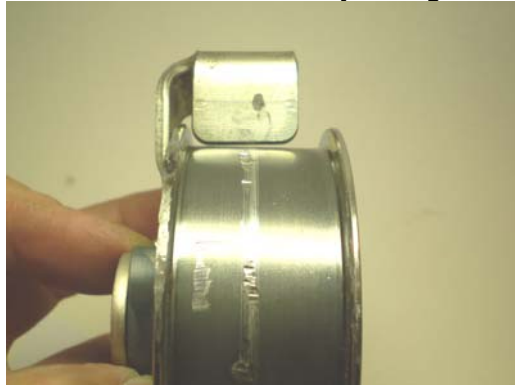
Belt drive failure soon after installation of the kit due to the tension pulley breaking off.

Broken off tension pulley

The stud bolt must always be inserted as far as it will go into the engine so that the screwed-on contact surface of the tension pulley can be fully supported on the cylinder block without any additional loads being generated.

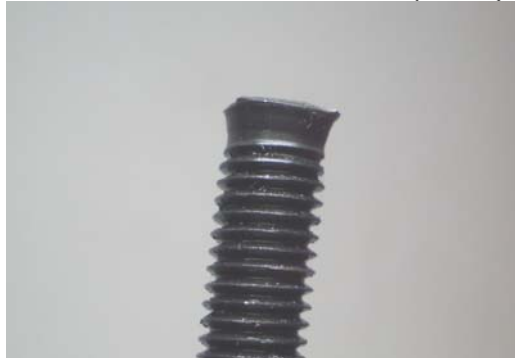
The tension pulley was unable to gain full supporting purchase on the engine. This resulted in the action of lateral forces on the stud bolt, which subsequently broke.

Stud bolt at transition (M10)
