Technical *Info*

Failure of idler pulley due to overheating of cover layer – CT 1105 K1 (1.9-JTD engines: Opel, Alfa Romeo, Fiat and Saab)

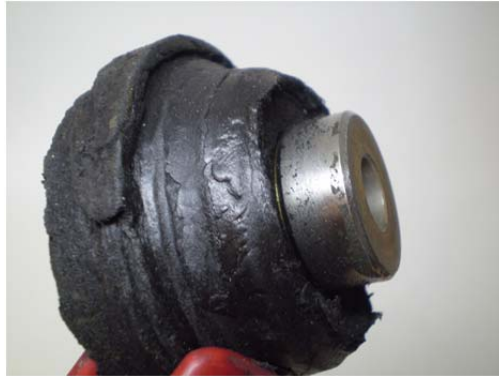
The belt drive fails due to the outer plastic of the idler bearing becoming overheated and melting, the back of the belt is also heat damaged.

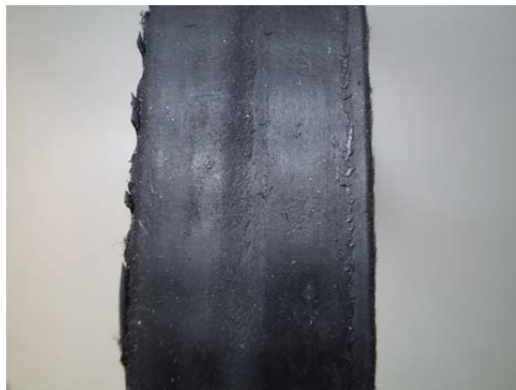
The failure is caused by a blocked water pump. The belt slips over the blocked pulley causing the back of the belt to become overheated, this heat is then transferred to the plastic idler pulley causing it to melt. When the Idler melts the tension is lost and the belt drive fails.
