To fit:

various Volkswagen, Audi, SEAT
and Skoda models

Ignition coil

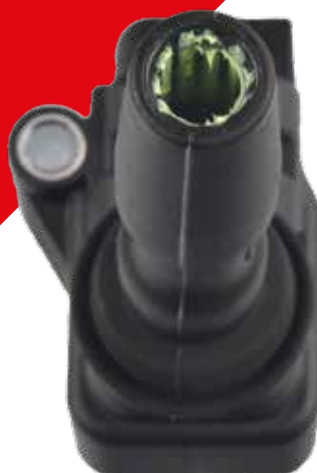
Figure 1

The ignition coil has failed, causing the engine to misfire. Due to the ignition timing being controlled individually for each cylinder, the corresponding injector will no longer be activated if an ignition coil stops working. Consequently, a fault code entry will be made in the 'error memory' of the engine control unit, relating to cylinder combustion failure and cylinder shut-off, and the EPC warning lamp will illuminate.

During regular maintenance, the ignition coils need to be removed to gain access to the spark plugs for their replacement. However, due to prolonged engine heat cycles the rubber insulation of the ignition coil can become 'bonded' to the ceramics of the spark plug - resulting in excess force being required to remove the ignition coil. The rubber insulation can then become damaged and split, which can go unnoticed. When a damaged coil is refitted, arcing within the cylinder head can occur. Once again, this is not always immediately apparent.

After removing the ignition coils from the cylinder head during the spark plug replacement process, carefully inspect the rubber insulation for any splits or damage that could lead to failure. This is highly recommended if the ignition coil has been subjected to excess force when trying to remove them. The coil should then be replaced to reduce the risk of ignition failure and ensure engine reliability.

febi ignition coil 40321 is equipped with dielectric grease applied within the rubber insulation tube (Fig.1) which is non-conductive and eases the fitment of the coil as it is inserted onto the spark plug - therefore reducing the risk of it becoming 'bonded' to the ceramics of the spark plug for future repair and maintenance of the ignition system.
