febi 47197, 48897, 81368, 81369

Volkswagen, Audi, Seat, Skoda, various models

Oil Drain Plug and Special Tool

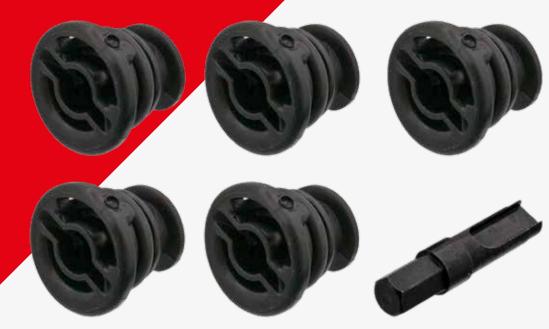
Plastic oil drain plugs should always be replaced and a special tool is required for their removal and installation.

The problem has resulted because of over tightening of metal drain plugs, stripping threads and causing oil leaks.

The plug turns and then clicks into place. A tooth on the plug, and a notch in the face of the sump ensures the plug is locked into the correct position. It can only be fitted correctly and cannot be over tightened.

Plastic sump plugs have been introduced into the Volkswagen, Audi, Seat & Skoda vehicle range. As the plugs are made of plastic it is imperative that the correct tool is used to prevent damage to them.

The special removal tool is available on its own, (febi 81368) or as part of a kit. (81369)
