SI-180807

Service-Information Turbocharger

Vehicle Manufacturer: VW, Audi, Seat, Skoda Vehicle: Touran, Golf, Jetta, Caddy, Passat, A3, Altea, Leon, Toledo, Octavia, Superb Engine code: AVQ, BJB, BKC, BRU, BXE, BXF

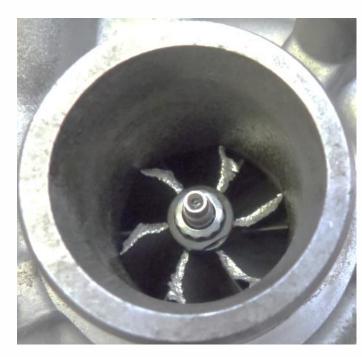
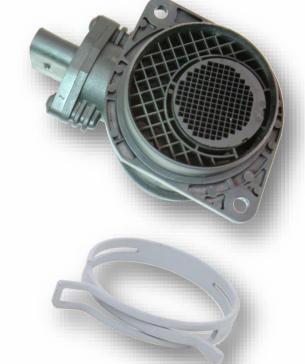
These vehicles repeatedly suffer massive foreign body damage to the compressor wheel.

Damages to the compressor caused by aspirated foreign bodies. Malefactor is often the air mass meter. The aged components break inside when they are mounted with hose clamps instead of the provided spring band clamps.

In the event of turbocharger failure with a damaged compressor wheel, the following work must be carried out to avoid consequential damage:

- Air filter element and air filter box as well as suction hoses are to be checked for impurities and • damages and replaced if necessary.
- The air mass meter should be checked for mechanical damage and broken grid structures and replaced if necessary.
- Check the entire charge pressure line for contamination and damage. •
- The intercooler is to be renewed.
