Error from engine control unit: boost pressure too high/low**Stiff VTG adjustment, loss of oil on turbocharger****Warning:**

Oil leakage on turbocharger due to increased crankcase pressure.

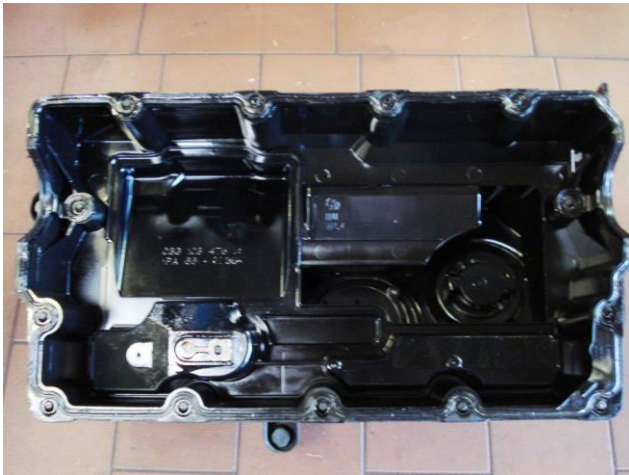
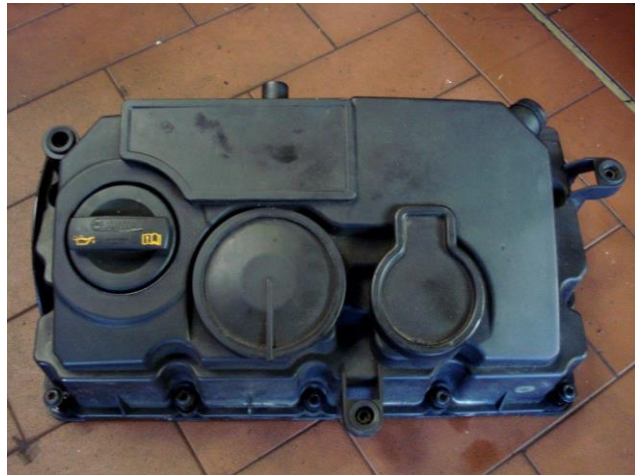
If the pressure is higher than 5 mbar the oil from the turbocharger cannot flow back into the oil pan freely. The result is loss oil even when the piston rings are completely unimpaired: The oil is pushed through the piston rings into the turbine and compressor housing.

The oil separator and the valve cover are one unit.

If oil is leaking through the housings of the turbocharger, please check the crankcase pressure in warm engine conditions (above 80°C).

Run the engine in idle mode for 3 minutes. If the pressure increases to more than 5 mbar, the valve cover with the oil mist separator has to be exchanged.
