Loss of power and noise due to rupture of Compressor back wall or control rod of the wastegate

Vehicle Manufacturer: Audi, VW, Seat, Skoda

Vehicle: 1.8 TSI/TFSI, 2.0 TSI/TFSI

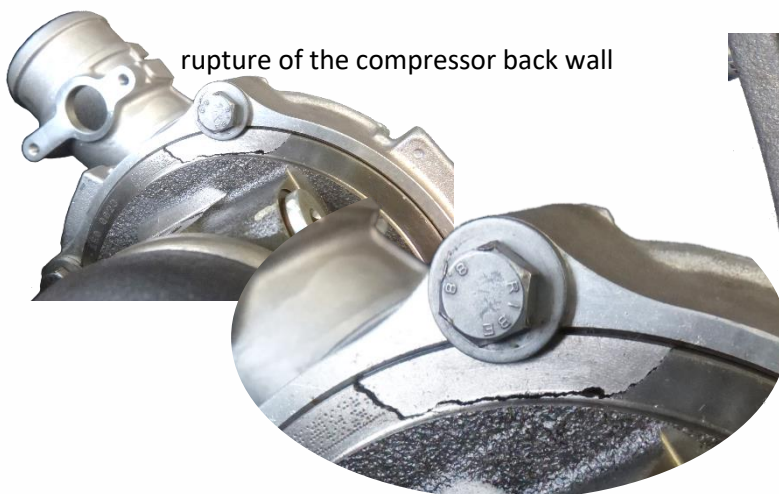
In some cases, noise from the turbocharger and / or loss of power, contrary to known causes of damage, is attributable to breakage of the compressor back wall or the control rod of the wastegate. These are fatigue fractures due to excessive mechanical vibrations from the entire aggregate.

A defective dual mass fly-wheel causes vibrations on the engine that lead to overuse of these components and its rupture. Worn engine mounts amplify the vibrations occurring on the entire unit. This type of damage is not covered by warranty.

rupture of the compressor back wall

Check the turbocharger to be replaced for any damage shown on the rear of the compressor. At least now, dual mass fly-wheel, engine mounts and other factors for vibration have to be checked and, if necessary, replaced.

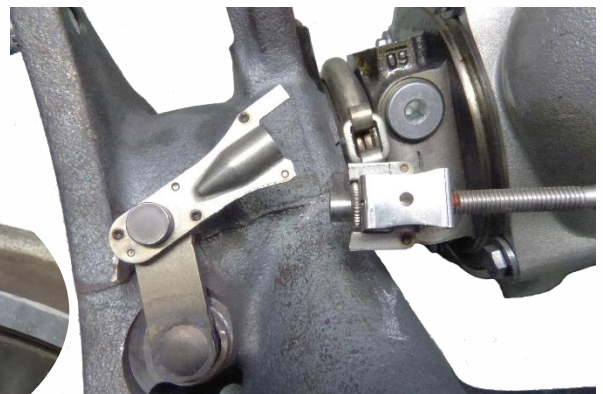
Breakage of the control rod
