This new version replaces all previous versions. Please replace SI-100604

Bearing damage to the turbocharger by coked oil supply lines

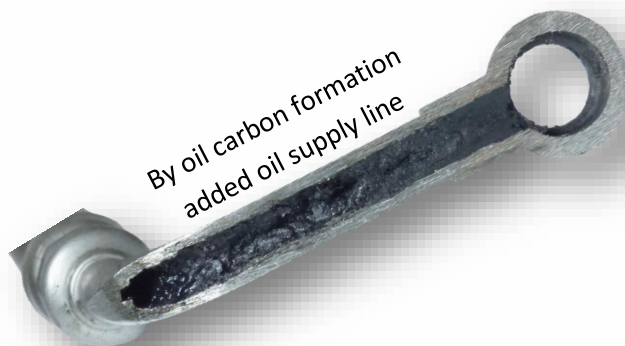
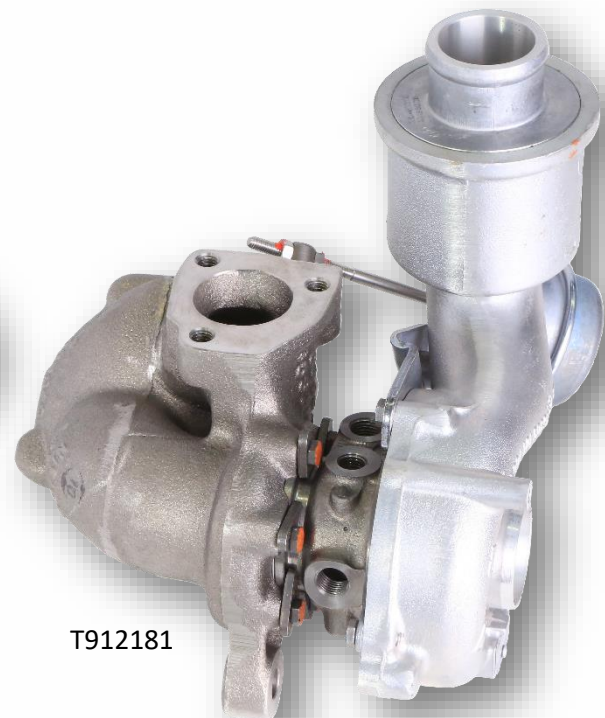
These vehicles usually come with loss of power and noise in the workshop. Usually excessive bearing clearances be found on the turbocharger, which make an exchange necessary. In many cases, the cause is due to a coked oil supply line of turbos.

Due to their construction, the oil feed line in the region of the turbocharger is very close to the turbine housing and exhaust manifold. After stopping the engine, the radiation heat acts freely on the surface of the oil supply line. After switching off the hot engine, the stationary motor oil overheats on the inside of the oil line. It comes to coking which constrict the line cross section continuously. The reduced oil flow reduces the cooling capacity in the bearings of the rotor shaft. There it comes to overheating and formation of oil carbon. This oil carbon causes the removal of material at the bearing points and the observed wear (excessive bearing clearances).

When replacing the turbocharger always renew the oil feed line as well as the oil return line. Only flushing the lines never achieves the desired success. Repeated turbocharger failure is promptly to be expected.
