Blue Print ADBP990016, ADU172101

To fit:

various Mercedes-Benz models

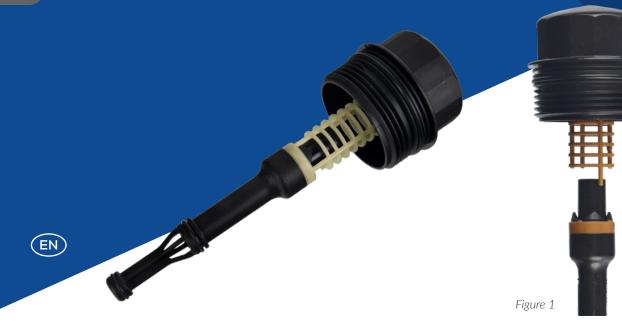
Whilst changing the engine oil filter during the service replacement process, the oil filter housing cap can break - leaving the oil filter alignment tube and element within the housing. (Fig.1)

After many hours of operation and continuous exposure to the engine oil heat cycles and vibration, the original oil filter housing cap alignment tube material becomes brittle and snaps.

Remove the oil filter element, and the remains of the oil filter housing cap alignment tube, from the housing. Check for any broken fragments and remove them, along with any excess oil. Replace the oil filter housing cap with Blue Print part ADBP990016 (which is supplied complete with all "O" ring seals), along with oil filter element ADU172101. Lubricate the seals with the engine oil and tighten the housing cap to the recommended torque of 25Nm.
