Land Rover Defender / Discovery 1 90/110/130 2.5DT 200/300 Tdi 1989>1998>

CLUTCH KIT OR CLUTCH RELEASE FORK REPLACEMENT

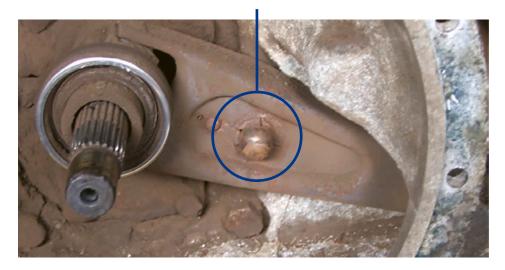
On removal of the gearbox, the clutch release fork may have worn through at the pivot point.

The clutch fork will need replacing (Blue Print ADJ133302).

It is best practice to check the condition of the clutch assembly and spigot bush and replace as necessary whilst the gearbox is removed.

Ensure the pivot is lubricated with a small amount of suitable grease prior to re-assembly.
