Blue Print ADK87213

to fit:
Suzuki Grand Vitara 1998>2005

SUZUKI GRAND VITARA - CAMSHAFT POSITION SENSOR

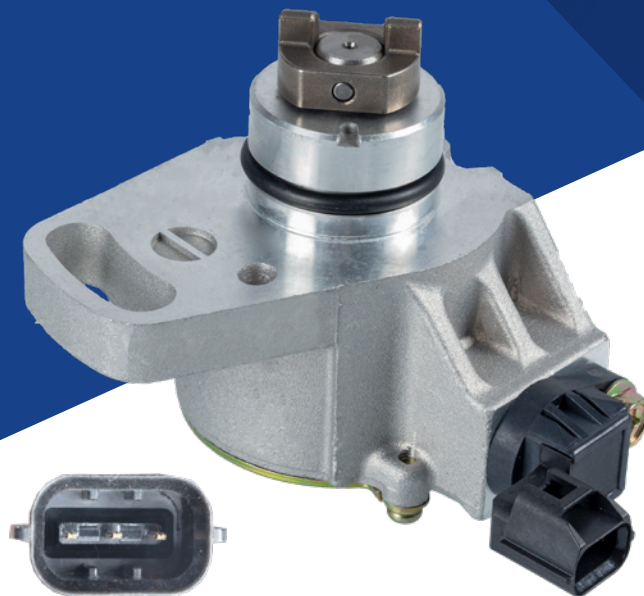
Engine fails to start.

No signal from the camshaft sensor, which is driven by the camshaft.

Note: When first diagnosing this sensor for possible signal failure ensure the exhaust camshaft is turning, whilst cranking, because of the common chain drive failures.

If replacing this Hall Effect camshaft sensor, the ignition timing needs to be checked and adjusted as necessary.

To set the ignition timing for this vehicle, the following procedure must be carried out.

- The engine should be at operating temperature and all loads switched off, idle speed 750+/-50 rpm.
- With the engine not running, set the vehicle in to its fixed spark mode, using suitable diagnostic equipment.
- Adjust the camshaft sensor by turning it to obtain the correct adjustment, checking with a timing light. 5°+/- 1°BTDC. Then tighten the fixing bolts.
- After checking the adjustment, end the fixed spark mode, stop and restart the engine.
- Recheck the ignition timing using a timing light, while the engine is idling, this should be 14°+/-2°BTDC.
- If the ignition timing is out of adjustment, recheck using this procedure.
