TSB #88

A-2642 BMW X5/X6 (E70/E71) (F15/F16) PROPER INSTALLATION AND INFLATION NOTICE

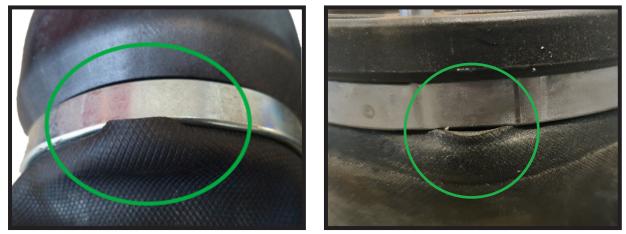
Air springs inflated without following the manufacturer's specifications/not supporting the vehicle can cause the force to distribute unevenly, which may result in crimp ring failure.

PROPER INSTALLATION & INFLATION PROCEDURES MUST BE FOLLOWED TO AVOID PERMANENT DAMAGE TO THE PART. WARRANTY WILL BE VOIDED IF THESE PROCEDURES HAVE NOT BEEN FOLLOWED.
