# STEER.

## HP102, HP1572 CONNECTING TO THE WATER PUMP

STEC.10007 18/07/22

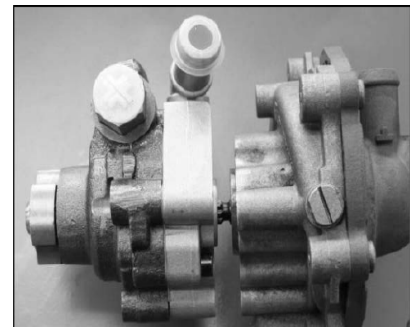
Figure 1

The HP102 and HP1572 have a splined shaft at the rear of the pump. This is used to drive the water pump which is connected directly to the unit.

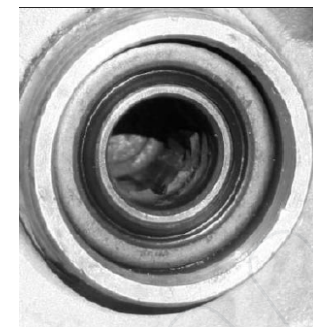
Figure 2

Care must be taken when connecting the two units. If excessive force is used this will alter the position of the splined shaft and so the pulley hub. The unit will malfunction if this occurs.

Units returned with damage to the spline, as shown in figure 2, Will not be credited.

We recommend that the securing bolts are tightened in sequence, a small amount each time until the unit is fixed. At no point should either unit be impacted. Wear in the water pump bearing or a water leak can cause premature failure of this spline. The water pump should be inspected during the installation of a new steering pump and replaced, if necessary.

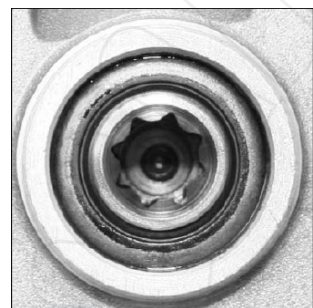
Figure 3

Shows a spline in good condition.
