### Attention in the Installation of Belt CT879

Vehicles Fiat Palio/ Weekend/ Siena/ Strada - engine 1.6 16V

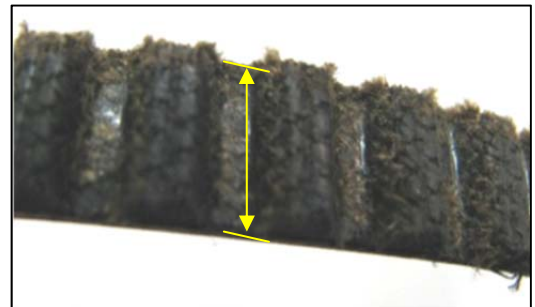
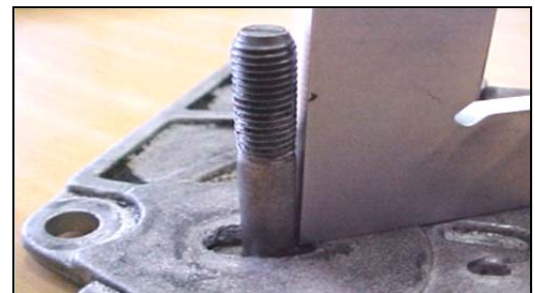
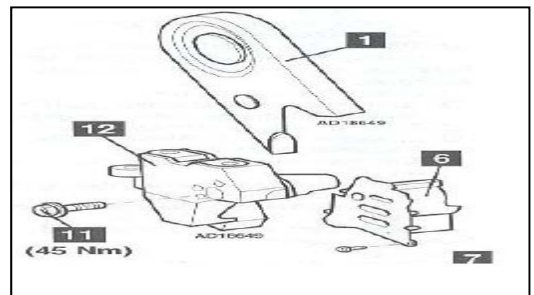
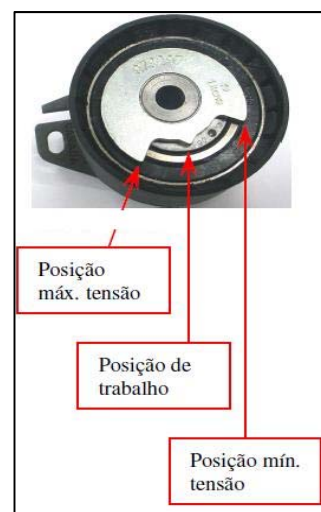
Reduction of the original width of the belt generated by the wear side. In some cases breakage of the belt.

Original Belt Width: **25.4 mm**.  
Verified the belt width: **11.32 mm**

Stud and or fixing the tensioner plate with angular misalignment.

Gaps in fixing the fairing or between the axes of rotation of the timing system require the parties to have contact between the fairing generating wear on the side of the belt.

The tensioner should be installed with proper tools. The code is 1860876000 Fiat tool.

The tensor must be in the correct working position.
