ContiTech

ATTENTION WITH TENSIONER FIXING BASE – FIAT ENGINES 1.6 16V Timing belt CT879s

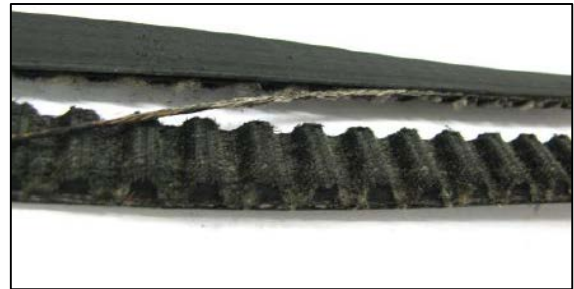
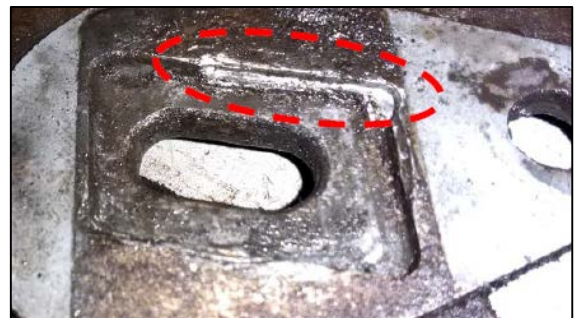
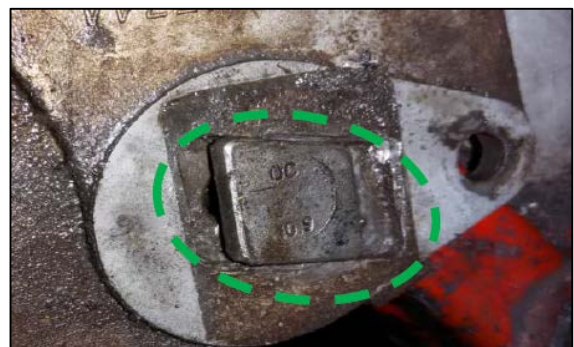
Wear on the belt side.

Incorrect assembly of the fixing screw to the mounting base housing.

Correctly position the fixing screw to the mounting base housing, being sure that there is no decentralization in engine timing set so that there is wear on the belt side.
