Clutch

Hard Clutch Pedal Issue

CLTB 0025

Affected references: BCS112, 143, 144, 157, 161, 187, 192, 201

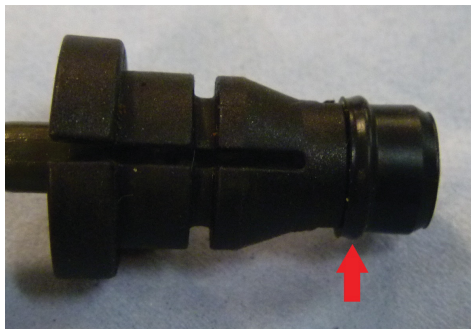
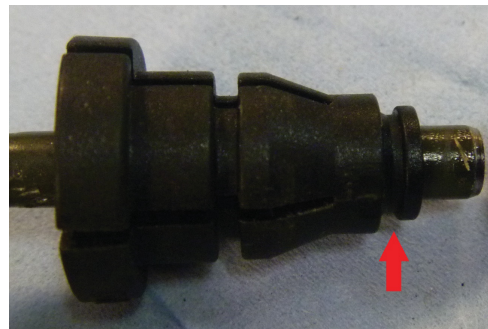
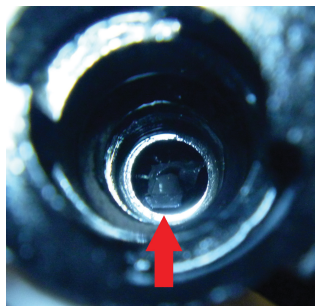
It should be noted that during the removal of the old CSC the seal on the connecting nozzle can detach and become stuck inside the connecting pipe. This causes a blockage when the new CSC is installed, which in turn results in the issue of a "hard clutch pedal"

(Blocked Port by CSC Seal)

After removal of the CSC always visually check that the seal is in place on the connecting nozzle and check for obstructions inside the connecting tube.
