# AUTOELECTRO

## STARTER MOTORS & ALTERNATORS

Mini R50/R52/R53 1.6 & 1.4 Petrol 2001-2009. All vehicles with W10 engine code are affected from 2003 onwards.

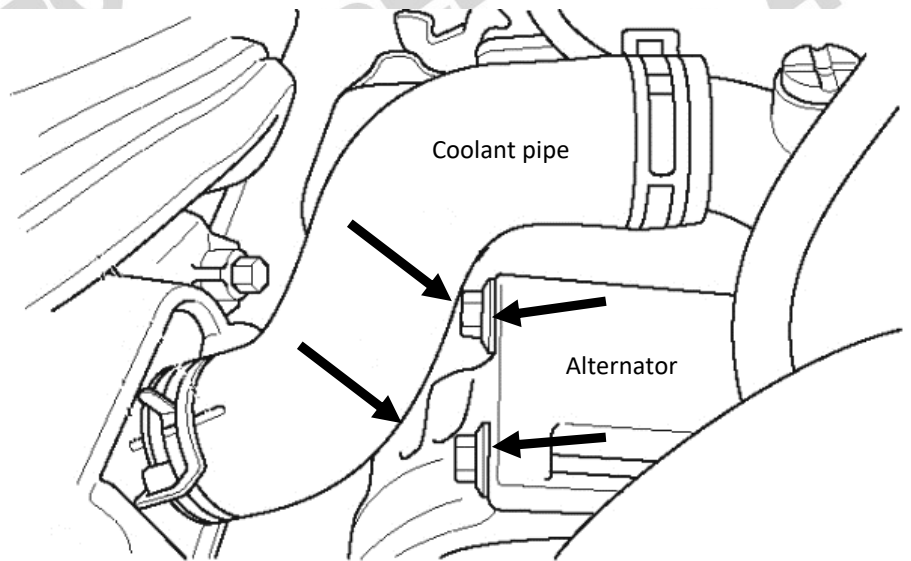
Alternators fitted to the above vehicle are being returned under warranty after replacement due to the drive belt slipping. Upon inspection there were signs of engine coolant on the drive bracket.

We have found that there is a coolant pipe which runs directly above the alternator and across the mounting brackets. When the original alternator has been removed the pipe has not been detached or moved into a safe position, perhaps to save time. By doing this the pipe chafes against the alternator mounting bolts causing leakage of coolant on to the alternator and the drive belt. This results in the drive belt slipping causing a charging fault/low charge rate.

In all cases when replacing the alternator on this vehicle the fitter must ensure that the pipe is clear from the mounting bolts when removing the alternator. If the pipe has been damaged it **must** be replaced
