CVJ – ENG/02 – 05/2019

CV BOOT KITS

Recommended clamp tightening procedures

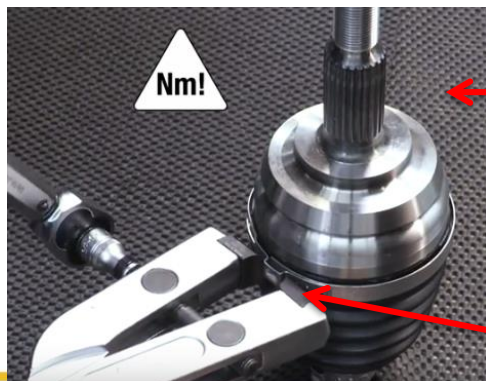
BOOT CLAMP MUST BE
HOOKED SURELY

. If the clamp is **not tight enough** :

($M_1, M_2 > \grave{a} 4\text{mm}$)

➤ Grease leakage

. If the clip is **too tight**:

($M_1, M_2 < \grave{a} 1.2\text{mm}$)

➤ The CV boot can split and allow grease to leak
