**Break of shift linkage**

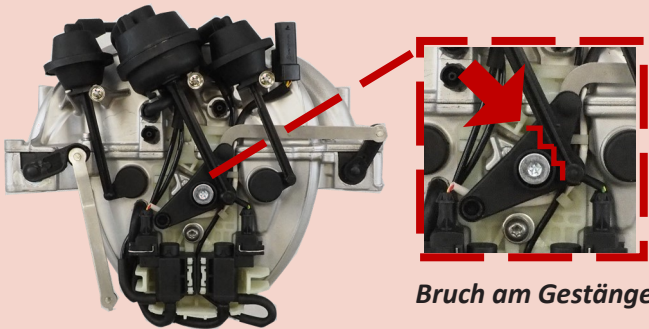
If the intake manifold module no longer functions properly, the cause is usually not the module itself, but a leaky line in the engine vent. This is located above the shift linkage on the intake manifold and can become leaky as a result of high stress or ageing, with the consequence that oil escapes and drips onto the linkage. If this is the case, you must replace this plastic pipe with an aluminium pipe.

Due to the interaction between thermal stress, vibration and the escaping oil, the plastic material of the linkage becomes porous and breaks.
