Early failure from heater and radiator by contaminated cooling system after a exchange

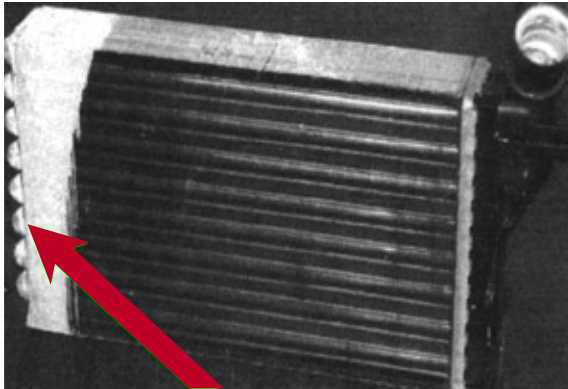
The leakage accumulates mostly in the near of U-arches. Different manufactures researched and find out if the cooling was not cleaned or flashed before the exchange; contaminants will stick on the turbolator and causes an early failure.

Picture 1 shows an absolute permeable heater installed since 9month in a car.

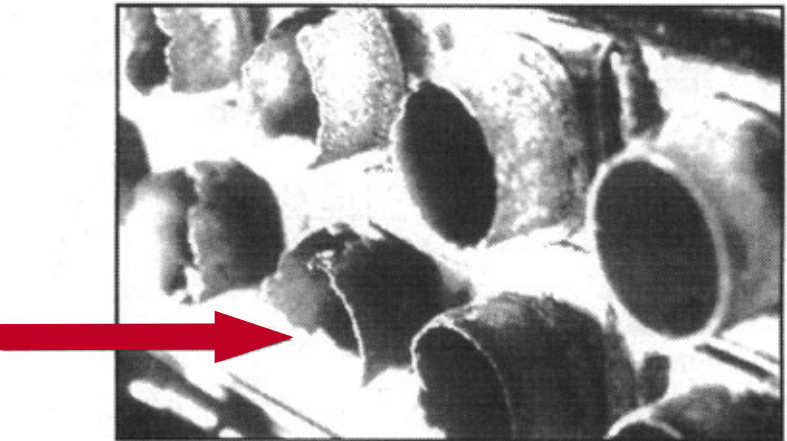
If contaminants accumulate on the turbolator, the corrosion process will interrupt for a short time and the blockage build up higher pressure, which causes a really fine stream of refrigerant under high pressure and creates holes in the U-arches.

Picture 3 shows how the corrosion corrodes aluminium tubes in the cooling block when the cooling system was not efficient cleaned or flashed, or used to less or wrong frost protection.

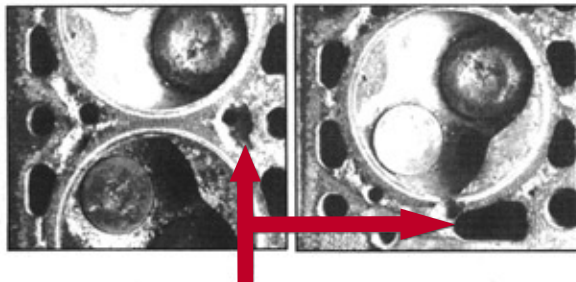
Picture 4 + 5 (top right) shows the cylinder head top with the affected by using to less or wrong frost protection. The released metallic contaminant circulates in the cooling system and blocks the little openings as the U-arches in the heater.

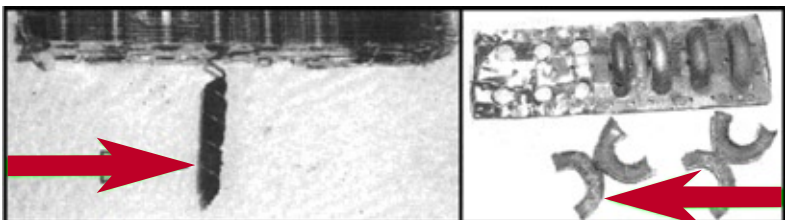
Picture 6 (top middle) shows contaminant accumulates to the turbolator which accelerate the corrosion process. Picture 7 (top right) shows any cut open U-arches. Inside the U-arches are visible traces from contaminant.
