RADIATOR HOSE WITH FLANGE AND COOLANT TEMPERATURE SENSOR

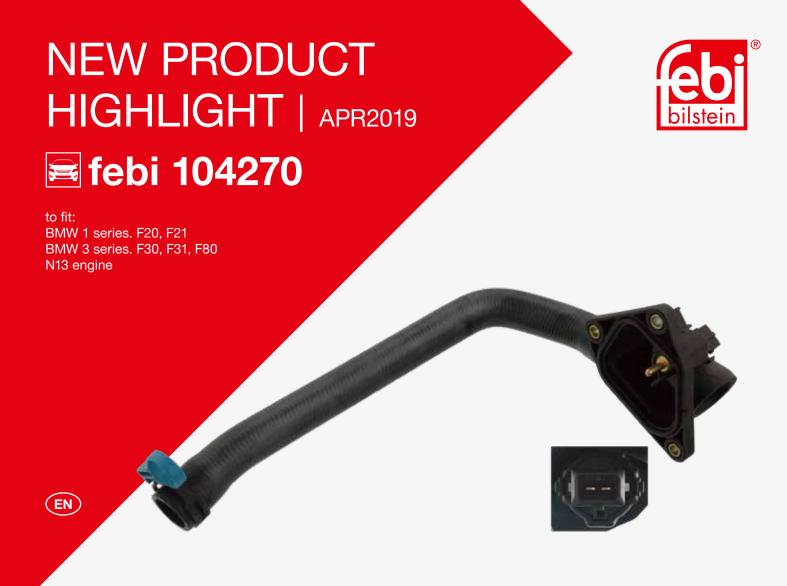
The coolant temperature sensor is located in a plastic housing and is located to the rear of the engine. This hose transfers the coolant from the rear of the engine to the thermostat housing, which is located at the front of the engine.

Due to its close proximity to the catalytic convertor, the coolant temperature housing suffers from constant exposure to heat which can cause the plastic housing/flange to crack. This can be most commonly found around the coolant temperature sensor, resulting in a coolant leak.
