NEW PRODUCT HIGHLIGHT | JULY2020

Adjustment Unit for Handbrake Adjustment

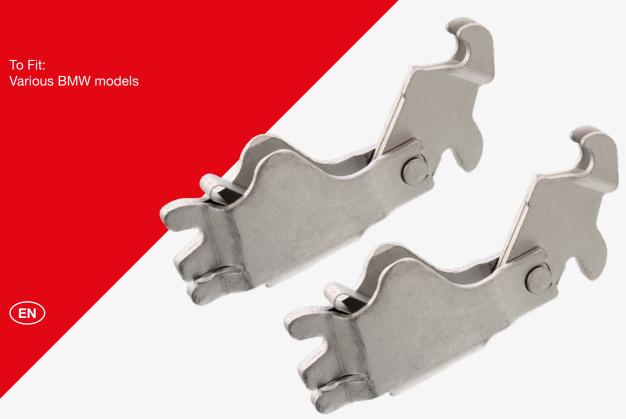
The handbrake lever pulls on the two cables which transmits the applied force to an expander (adjustment unit for handbrake adjustment) within the brake drum housing for each rear wheel. The expander is attached to the end of the handbrake cable. As the cable is pulled, it causes the expander to open. The expander is forced against the brake shoes where it then pushes the top of the shoes apart. In doing so, it presses the friction material against the inner surface of the brake drum. If the parking brake is functioning correctly, the shoes will press sufficiently to securely lock the wheel.

Seized operation of the expander or wear is quite common. This causes the parking brake shoes to bind or leads them to not be effective. The parking brake on these vehicles is a drum brake system integrated into the rear brake disc. As a result, the parking brake linings barely wear, and the condition of the hand brake can only be determined when the brake discs are removed. It is recommended that the hand brake shoe expander is replaced when the parking brake shoes are replaced, or, alternatively, every four years.
