CVJ – ENG/01 – 05/2019

Recommendations for the correct fitment of CVJ's

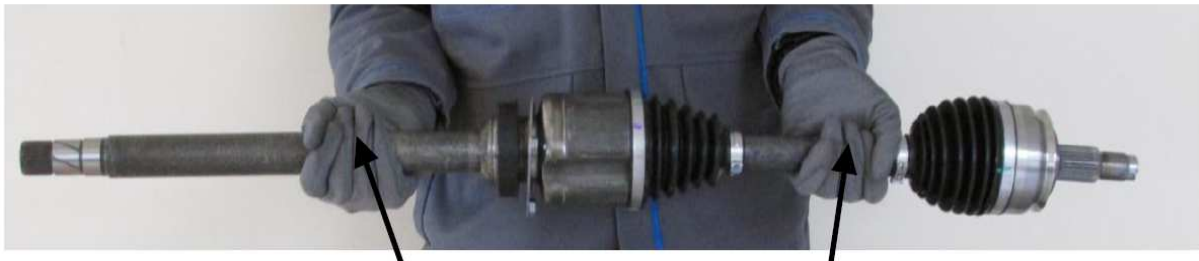
- Always hold the CV joint by the connecting shaft and the tulip section to stop the joints from pulling apart and damaging the internal components of the joints.

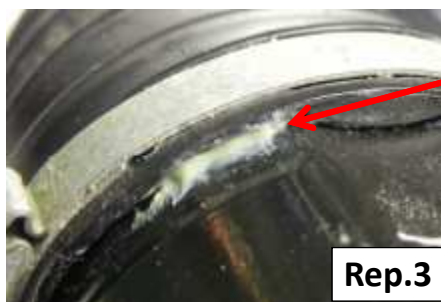
Incorrect tightening of the clamp (too high or not enough), will result in a loss of grease, this will cause component damage. **(Rep.3)**

Not enough tightening :
Grease leakage

The manufacturers fitting instructions and specified torque setting should always be followed. The correct tools should always be used for the removal and fitment process.

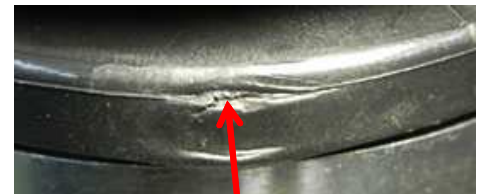
Tightening too strong : **Boot cutting caused**
