DPF350.01

Assembly/disassembly recommendations

BMW:	Series 1 (E87), Series 3 (E46/E90/E91/E92/E93), Series 5 (E60/E61), Series 5 LCI (E60/E61), X3 (E83), X3 LCI (E83)	ENGINES	OE reference
		2.0 D, 2.0TD	11 23 7 805 696, 11 23 7 801 977, 11 23 7 793 882

IDENTIFICATION OF DAMPER PULLEY DPF350.01

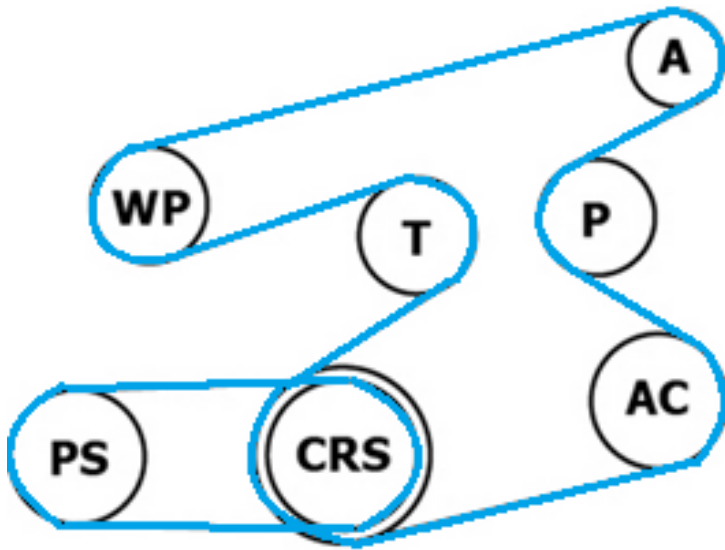
A	Alternator	P	Return pulley
AC	Air-conditioning compressor	PS	Power steering
CRS	Crankshaft	T	Tensioner roller
		WP	Coolant pump

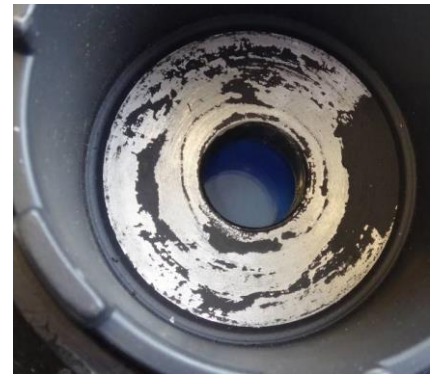
A retaining bolt incorrectly tightened allows the pulley to vibrate, and may even become noisy in some instances.

Spalling traces on the front contact face of the pulley are an indication of an incorrectly tightened retaining bolt.

The crankshaft pulley retaining bolt must be tightened correctly in four steps: **100 Nm + 60° + 60° + 30°**.

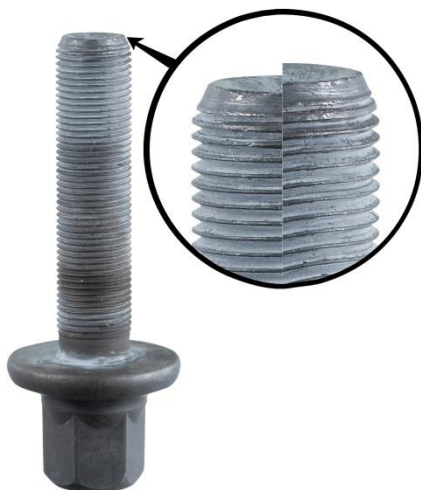
Bolt deformation

The dimensions of a new retaining bolt are **M18 x 1.5** with a maximum length of **85.5 mm**. It is essential to use a washer with this bolt.

During torque angle tightening, the bolt will become deformed and stretched. It is therefore recommended that a new retaining bolt is used when either a new or old pulley is fitted. Failure to do so can result in the pulley not being tightened correctly, allowing it to spin on the crank.

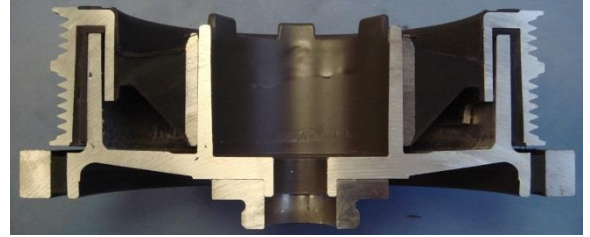
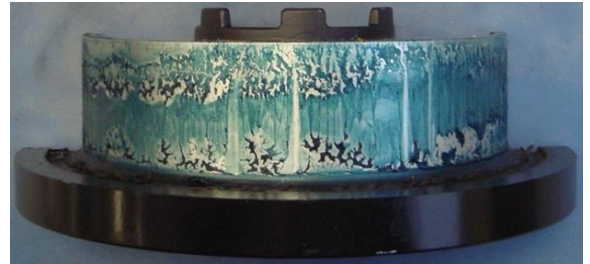
Composition

This crankshaft pulley is comprised of an outer aluminium pulley attached to an inner hub with an elastomeric (rubber) element sandwiched between them.

Sometimes a small amount of grease leakage can be seen from the rear plate of the pulley. This does not effect the correct operation of the pulley.

This pulley is made of aluminium, this means that it is very fragile, impact damage may cause the pulley to become unsuitable for use.

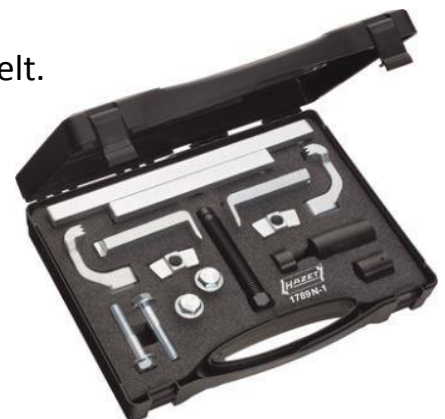
- Torque wrench and torque-angle spanner
- HAZET tool set: (pulley extractor)
Ref.1789N-1 for pulley removal

- 1) Remove the accessory belt
- 2) Remove the old crankshaft pulley
Use a HAZET extractor.
- 3) Clean any debris and dirt from around the crankshaft area

- 4) Reinstall the new crankshaft pulley on to the crank
- 5) Tighten the new retaining bolt to the recommended torques (making sure the a washer is in place)
- 6) Replace and tension the accessory belt
