SUSPENSION

SUSPENSION BEARING AND KIT

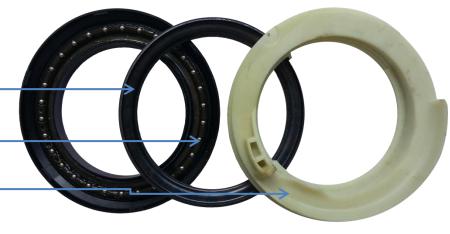
Tested NTN-SNR suspension bearing

- Hardened steel
- High quality lubricant appropriate to the application
- High quality plastic: glass fibre-reinforced polyamide (PA6.6 GV25)

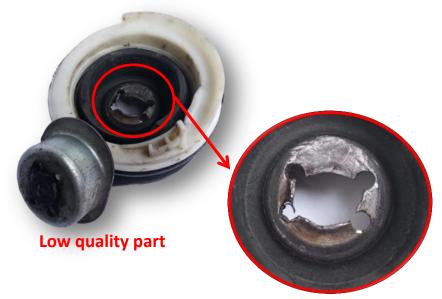
NTN-SNR kit

The shock absorber shaft has destroyed the metal insert of the insulator due to the poor quality steel being used. The NTN-SNR insulator design and high grade steel stops this shock damage from occurring.

Poor adhesion between the rubber and the metal inserts typically found in low quality parts causes them to fail rapidly. The use of such products can result in penetration or deformation of the bodywork during a heavy impact.
