KF155.70U

Assembly/disassembly recommendations

NISSAN:	Primastar, Primastar FL,
OPEL:	Vivaro, Vivaro FL
RENAULT:	Trafic II, Trafic II FL
VAUXHALL:	Vivaro, Vivaro FL

IDENTIFICATION OF BRAKE DISC HUB KIT

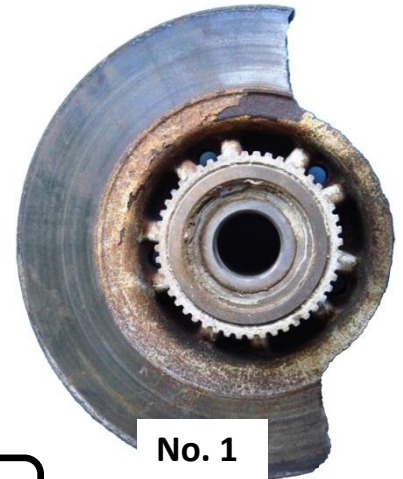
No. 1

Brake system malfunction.

This occurs when the calipers seize or the handbrake system locks up.

The disc remains locked and as a result the disc hub is subjected to a high increase in temperature. The brake disc inevitably fractures and breaks **(no. 1)**.

The vehicle should not be driven until repairs to the braking system have been made.

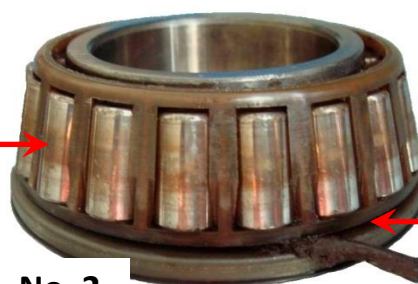
No. 2

Incorrect installation of the disc hub on to the stub axle.

Incorrect fitment of the disc hub assembly when mounting it on to the stub axle can lead to the disc hub assembly being fitted askew, this damages the inner rings of the bearing and prevents correct adjustment, this results in a rapid failure of the disc hub. Incorrect installation of the inner ring, which detaches from its raceway groove, causes the bearing to open. The open bearing then causes serious damage to the seal, this then allows contaminants such as water to enter the bearing **(no. 2)**. This results in rust damage causing the bearing to become noisy and greatly shorten its service life **(no. 2)**.

Corrosion on the bearing

Damaged seal detached from its raceway groove

This failure is irreversible, the bearing and disc have to be replaced as a complete unit KF155.70U
