# NEW PRODUCT HIGHLIGHT | JAN2020

## SWAG 30 10 9176

Various Volkswagen, Audi, Seat and  
Skoda models

### ADJUSTMENT MOTOR FOR RECIRCULATING AIR FLAP

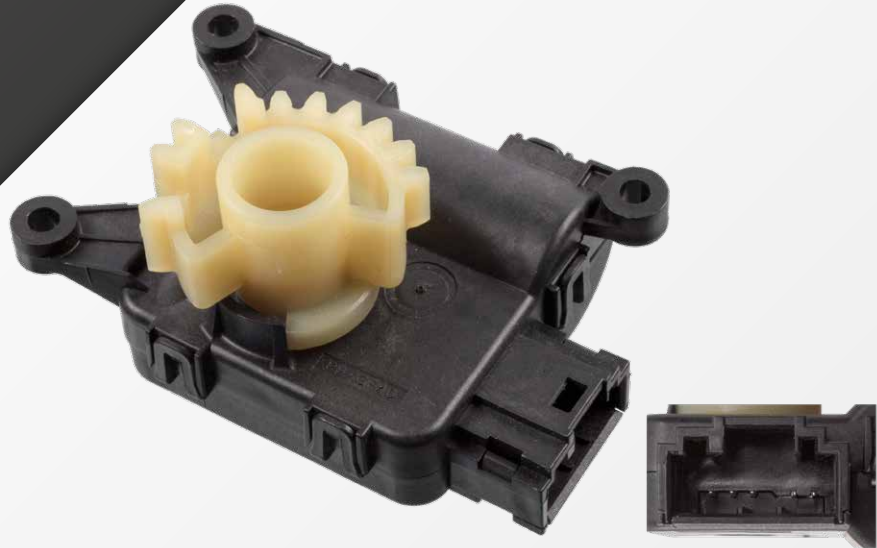
To operate the interior heater recirculating air flap, for the mixture of the air into the cabin, which is operated by the heater controls.

A clicking noise from behind the glovebox area, after the engine is started. This noise is from the heater recirculation air flap motor, due to a worn gear drive.
