## SWAG 20 94 5192

To fit:  
Land Rover Freelander TD4,  
Range Rover TD6

## Breather Valve for crankcase, with additional parts

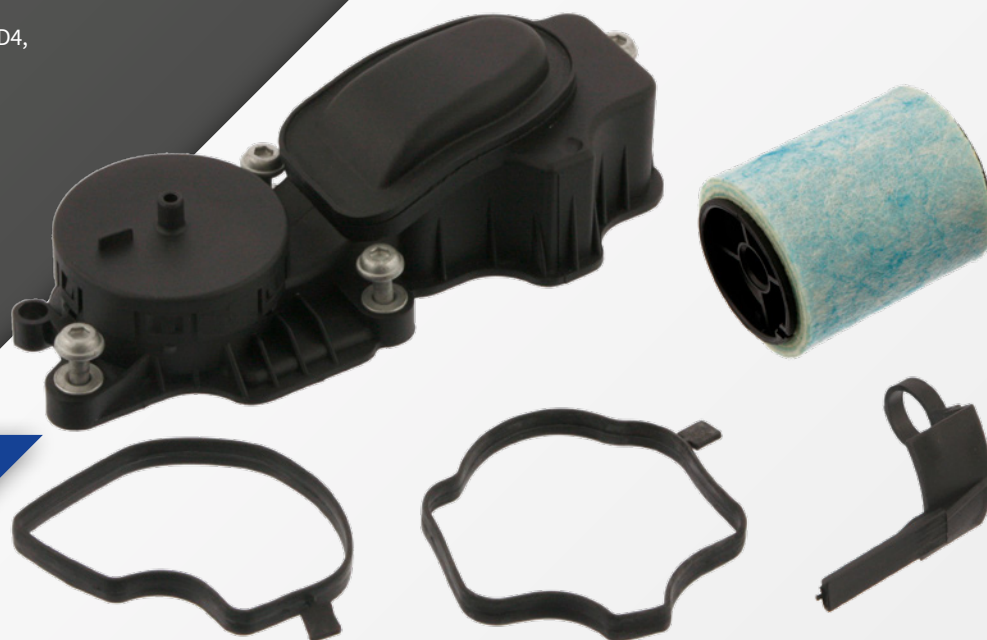
Engine oil leak, usually from the dipstick tube, because the dipstick has been pushed out under pressure.

Other symptoms include lack of engine power; the engine will not increase in speed, black or blue exhaust smoke and excessive oil consumption.

Excessive crankcase pressure caused by a blocked crankcase breather filter, this is located in the depression control valve assembly, which is fitted to the camshaft cover.

Replace the blocked filter and the complete breather valve assembly. Clean any excess oil leaks and test.
