SWAG 30 94 6748

To fit:
various Volkswagen, Audi, SEAT and Skoda models

Expansion bottle with sensor

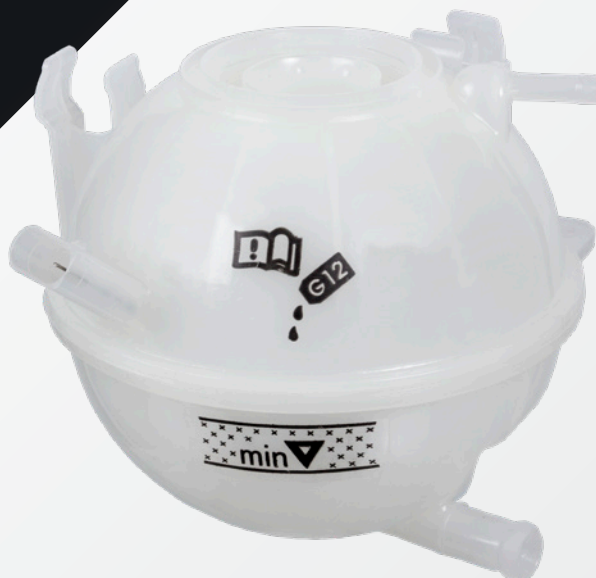
The message 'STOP', 'check coolant', or the low coolant warning lamp is flashing on the instrument display - depending on vehicle model. Upon checking the coolant level, the level in the expansion bottle is correct and there are no signs of coolant leaks.

Over time, contaminated coolant causes deposits to build up on the submersed contacts of the coolant level sensor within the expansion bottle. This affects the electrical resistance value of the sensor and, therefore, gives an incorrect reading of the coolant level. These contacts can be seen by looking through the expansion cap aperture. Coolant can also migrate into the electrical connector; this can be identified by a crystalline build-up in the electrical connector caused by a capillary action into the wiring harness. If this has occurred then the wiring harness will have to be assessed to make the appropriate repair.

Allow the engine to cool before working on the cooling system and then drain the cooling system of the old coolant.

Remove the two expansion tank retaining bolts and disconnect the electrical connector. Then, remove the attached hoses to remove the old part.

Fit the new SWAG expansion bottle (30 94 6748) along with a new cap (30 10 3522), using the two retaining bolts. Connect the electrical connector and the hoses. Refill the cooling system with fresh coolant mixture or pre-mix into the expansion bottle of the recommended coolant type for the vehicle. Finally, bleed the cooling system of any air.
