SWAG 30 94 7197,
30 98 1368,
30 98 1369

to fit:
Volkswagen, Audi, Seat, Skoda,
various models

Oil Drain Plug and Special Tool

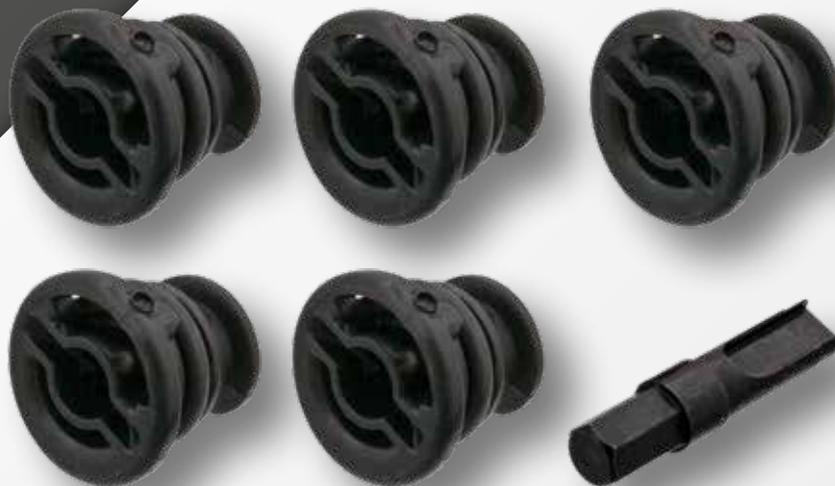
The plug turns and then clicks into place. A tooth on the plug, and a notch in the face of the sump ensures the plug is locked into the correct position. It can only be fitted correctly and cannot be over tightened.

Plastic sump plugs have been introduced into the Volkswagen, Audi, Seat & Skoda vehicle range. As the plugs are made of plastic it is imperative that the correct tool is used to prevent damage to them.

The special removal tool is available on its own, (SWAG 30 98 1368) or as part of a kit (SWAG 30 98 1369).
