SWAG 40 93 3748

To fit:
Vauxhall, Opel Corsa C, Combo C, Tigra, Vita

Wiper motor

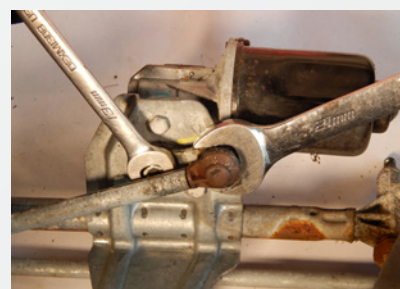
Figure 1

Undo the linkage-retaining nut to the motor-splined drive and remove the three motor-fixing bolts; this is in order to remove the motor from the linkage. (Fig. 1&2) Attach the new motor to the linkage, which is supplied with self-tapping bolts that thread into the fixing holes when the bolts are screwed into the new unit. (Fig.3)

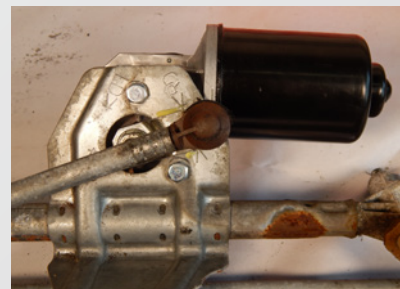
Figure 4

Align the wiper linkage to the splined drive of the motor, making sure it is aligned between the arrows marked LH or RH - depending on vehicle specification - and tighten the new nut supplied. (Fig.4)
