SWAG 50 93 2418 83 10 3186

To Fit:
Ford, Mazda and Volvo (various models)

Control Arm Bush

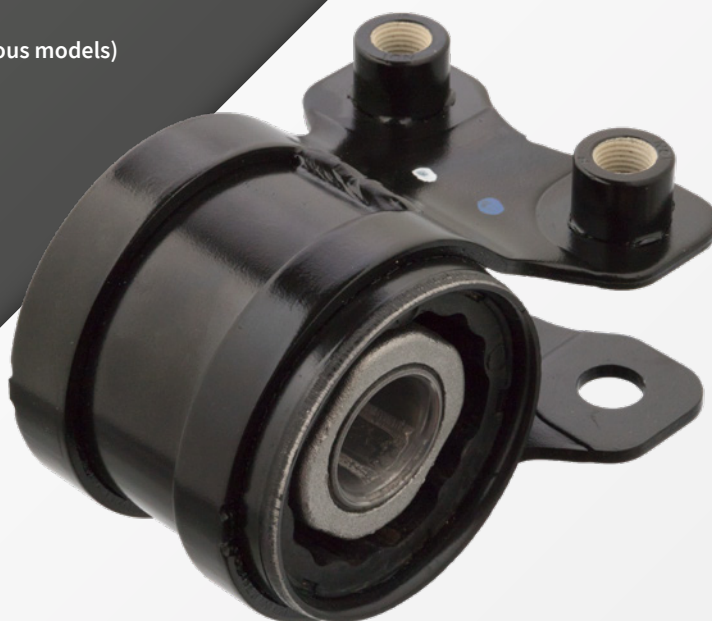
Uneven tyre wear and misalignment of the front suspension.

The lower suspension control arm bush is worn.

SWAG provides an economical repair solution whereby the control arm bush can be replaced instead of the complete suspension control arm.

When replacing this bush it is important that the alignment of the original control arm bush is followed.

If the bush is not aligned correctly on the shaft of the suspension arm then there is a risk of premature failure and a shortened lifetime of the component.

Note: There is a special tool available from the vehicle manufacturer to assist in the replacement of the control arm bush. By using this tool it can be ensured that the installation position and press-fit depth of the bush will be correct.
