SWAG 32 93 0816

to fit:
VW Touareg, Multivan T5, Transporter T5
with 2.5 TDI and 5.0 TDI engines

Alternator Coupling Pulley Kit

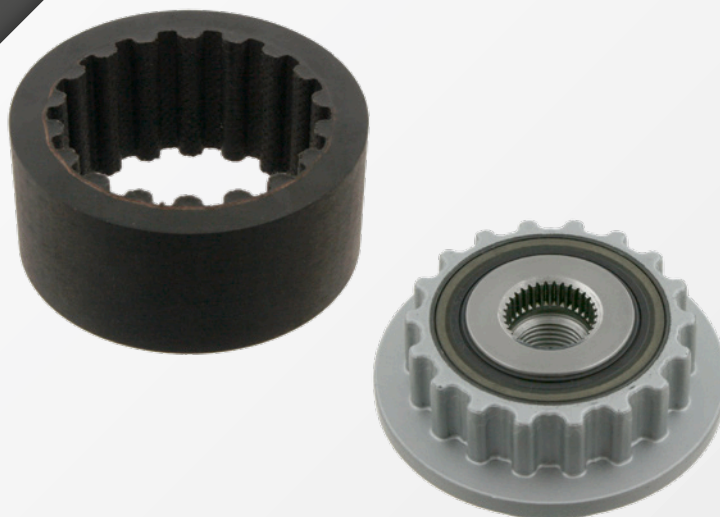
Severe vibrations and unusually loud noises in the ancillary drive area may be the warning signs of imminent failure of the freewheeling alternator pulley.

The alternator coupling transfers the torque to the alternator and air-conditioning compressor to dampen vibrations between the connected shafts. Belt alignment and service intervals are critical in this respect, when replacing the alternator freewheel and the alternator coupling, the alternator and/or air-conditioning compressor should also be removed. The alternator is fitted together with a bracket. If both components are separated, after fitting, the alternator becomes misaligned. The result is that the alignment is no longer correct and the alternator coupling can break (see Fig. 1). However, a defective alternator freewheel can also cause damage, it causes the alternator coupling to be overloaded, which can lead to it breaking.

As the alternator should not be separated from the bracket, it should be removed and fitted complete with bracket during repairs. SWAG strongly recommends paying close attention to the service intervals for the alternator freewheel and alternator coupling: in vehicles without diesel particulate filters (DPF), this replacement should take place every 150,000 km, and in those with DPF, every 180,000 km.

SWAG also advises that the alternator freewheel should always be replaced at the same time as changing the alternator coupling. We therefore offer the coupling along with alternator freewheel in a complete kit (SWAG no. 32 93 0816 / Repl. no. 070 903 201 E S1). Alternator freewheel (SWAG no. 32 92 6958 / Repl. no. 070 903 201 E) and coupling (SWAG no. 32 93 0798 / Repl. no. 070 903 327 D) are available individually.
