This new version replaces all previous versions. Please replace SI-110520

Strong carbon deposition and metal abrasion in the oil lead to increased turbocharger damages on these 1.6 HDI engines.

Vehicle manufacturer: PSA engines 1.6 HDI; 66kW/80kW

BTS reference: T914333

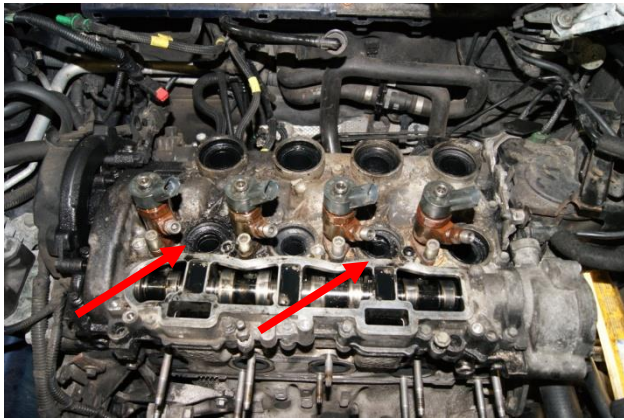
Bild 1: Re-seal the gas leakages on the exhaust manifold

- **Clean the exhaust manifold thoroughly, check for correct function, exchange if necessary, exchange sealing rings**

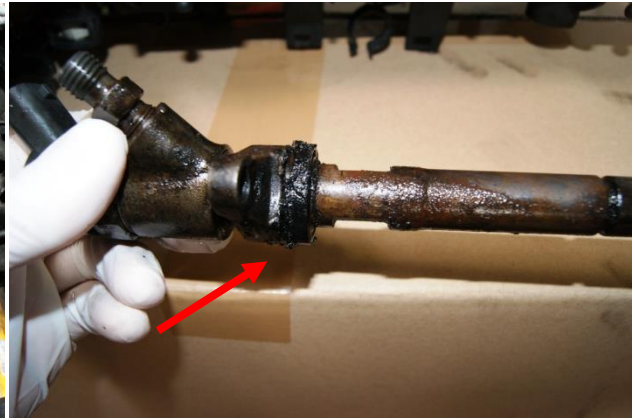
Bild 2: Re-seal the leaking holding bracket of the injection nozzle

- **Suck off oil residue clean the cylinder head thoroughly, suck off remaining residue.**
 - **Dismount and exchange the hydraulic lifters**
 - **Check the injection nozzles (sealing!), clean and exchange the seals (sealing ring cylinder head!).**

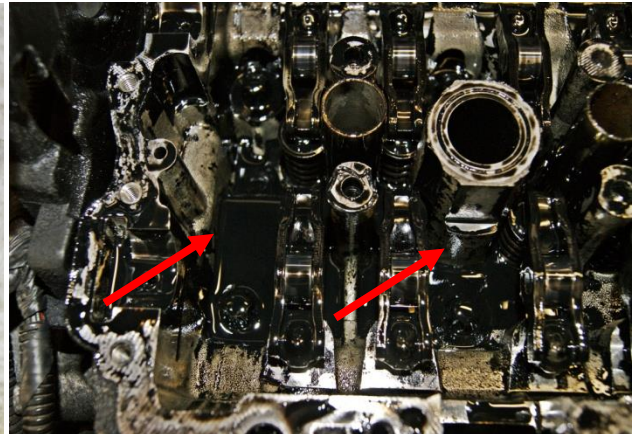
Bild 4: The oil remains in the cylinder head and develops into gel – **suck it out!** Remove all residue from the suction channels
