# NEW PRODUCT HIGHLIGHT | OCT2020

## Blue Print ADBP210027

### OIL FILTER HOUSING WITH COOLER

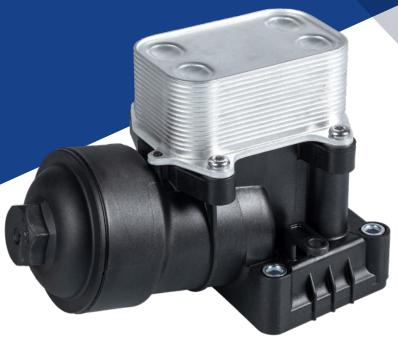
The plastic casing of the oil filter and the oil cooler which is made of aluminium are combined to form an oil filter module. The main functions include oil filtration, oil cooling, and oil mist separation. The assembly consists of the cap, housing, filter, and a filter by-pass valve which is integrated into the oil filter module. This valve opens if the oil filter becomes clogged; this ensures lubrication of the engine and the integrated retainer for the oil filter element.

The module is attached to the cylinder block and coolant is supplied directly to the oil cooler via the cylinder block to keep the oil temperature within specified parameters.

During oil filter replacement, overtightening (maximum torque 25Nm) or cross threading of the oil filter cap can occur, causing cracking of the oil filter housing and/or the cap. This can cause an oil leak from the assembly.

The aluminium oil cooler will corrode internally if incorrect coolant is used to top up the cooling system. This can lead to the reduction of the relevant inhibitors and eventually could cause an internal coolant leak. As the engine oil circuit is under greater pressure than the coolant system, oil will tend to leak into the coolant circuit. This can be identified by the coolant colour changing to brown.
