Blue Print ADP154305, ADP154351

To fit:
Various Peugeot, Citroën and DS models

Rear Brake Disc with wheel bearing

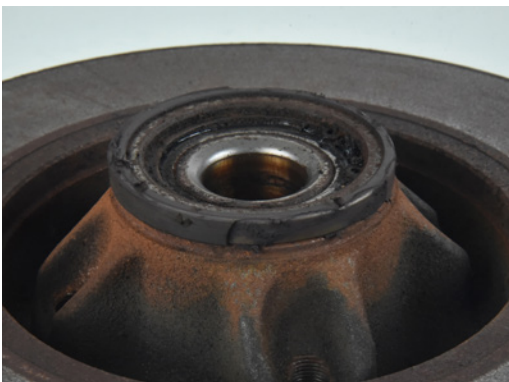
Fig. 1 Damaged reluctor due to contact with the sensor

With the old brake disc removed from the vehicle, the wheel speed sensor should be inspected for excess corrosion surrounding the mounting area. It is important to note that any excess metal corrosion can alter the position of the sensor – affecting its functionality. This can lead to direct contact with the reluctor, causing damage to the new brake disc assembly (Fig.1). Subsequently, an increased air gap between the sensor and the reluctor can also occur, resulting in an anti-lock brake system fault – logged as a sensor implausibility signal fault code in the brake control unit.

Therefore, during the installation of a new brake disc it should be identified if the speed sensor is in contact with the multipole reluctor, or if the air gap is not correctly aligned. If discovered to be incorrect, the brake disc and speed sensor should be removed. The sensor seating location should be cleaned of corrosion and - if damaged - the sensor refitted or replaced. With the new brake disc re-installed, and the sensor correctly aligned, a clear 1-2mm air gap between the reluctor and the sensor will be visible (Fig. 2).

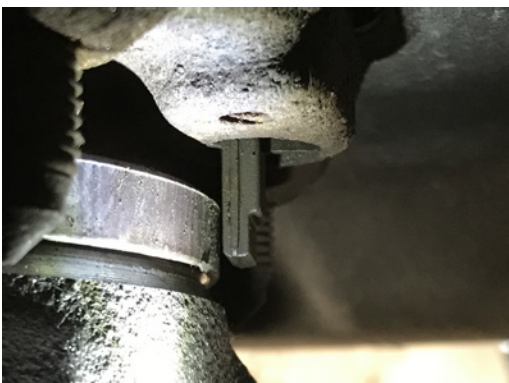
Fig. 2 Brake disc and sensor correctly installed
