To fit:

various Volkswagen, Audi, SEAT
and Skoda models

Ignition coil

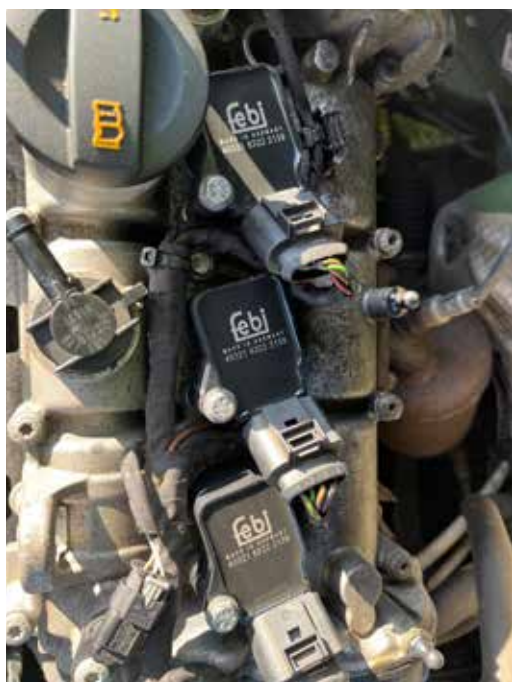
Figure 1

febi ignition coil 40321 is equipped with dielectric grease applied within the rubber insulation tube (Fig.1) which is non-conductive and eases the fitment of the coil as it is inserted onto the spark plug - therefore reducing the risk of it becoming 'bonded' to the ceramics of the spark plug for future repair and maintenance of the ignition system.

After removing the ignition coils from the cylinder head during the spark plug replacement process, carefully inspect the rubber insulation for any splits or damage that could lead to failure. This is highly recommended if the ignition coil has been subjected to excess force when trying to remove them. The coil should then be replaced to reduce the risk of ignition failure and ensure engine reliability.
