TSI 02/08

Cam cover gasket for OM 400 Mercedes-Benz

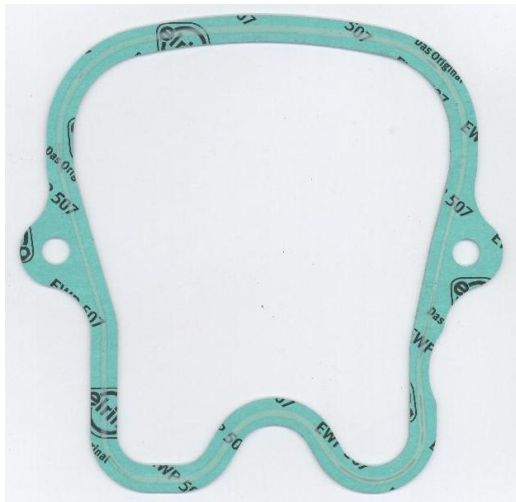
Soft material 1.5 mm
 476.050

If the cam covers are not surfaced, it is recommended to install the cam cover gasket made of **EWP soft material** **476.050**. With a thickness of 1.5 mm, this cam cover gasket compensates for component distortion more effectively.

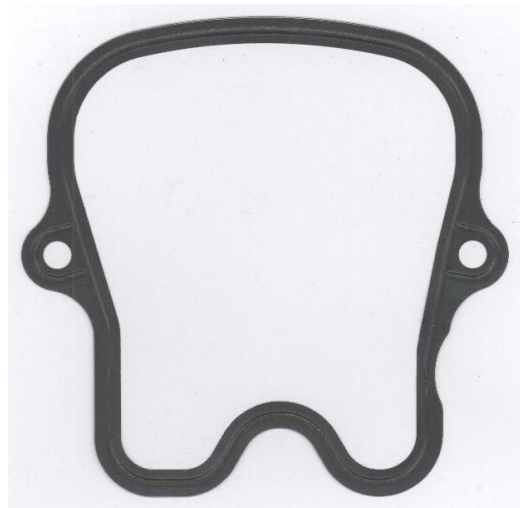
Metaloseal 0.4 mm
 977.438

For years, these engines are fitted ex factory with the technically high-quality **Metaloseal gasket** **977.438**. This gasket has a thickness of 0.4 mm. Valve covers must not show any warpage.
