NEW PRODUCT HIGHLIGHT | OCT2019

febi 103206

Turn Indicator Switch

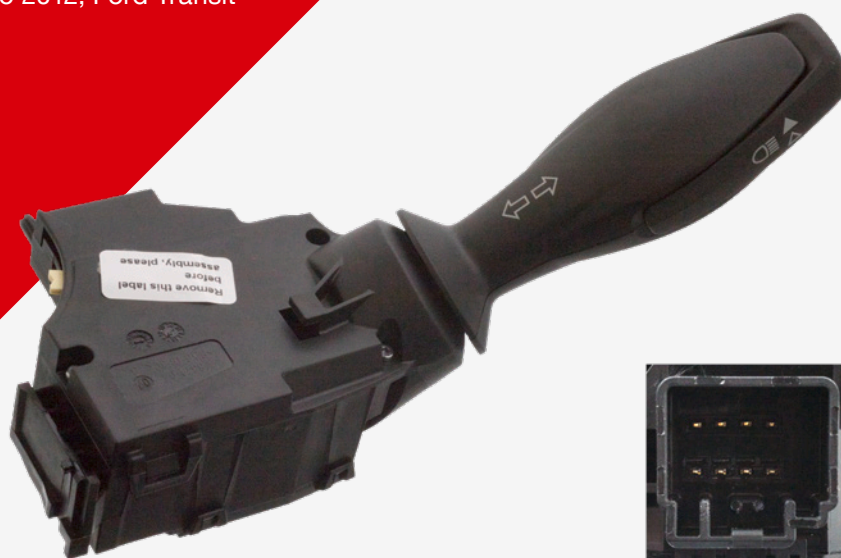
Steering column mounted switch that operates the direction indicators and main headlamp beam.

The direction indicator not cancelling due to the switch sticking in one position and failing to return to its central position. This commonly affects the left hand indicator.
