WHEEL : KF155.81U

Removal/installation recommendations

RENAULT: LAGUNA II (BGO), LAGUNA II
Phase 2, SCENIC II

IDENTIFICATION OF NTN-SNR BRAKE DISC HUB KIT KF155.81U

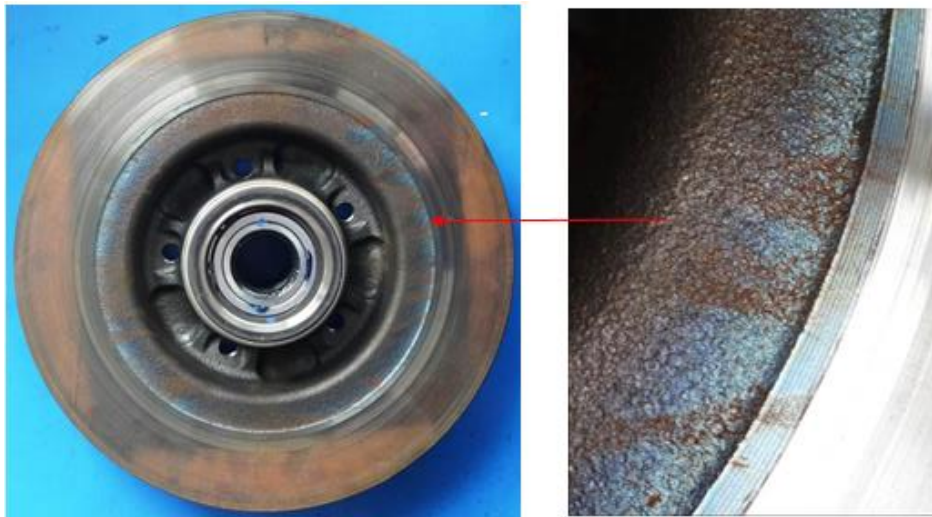
Rear brake disc hub over heating

If the calliper or parking brake are not releasing correctly it can cause abnormally high temperatures in the disc hub, this high heat often leads to bearing failure and disc damage.

Check that the brake calliper and parking brake are operating correctly/

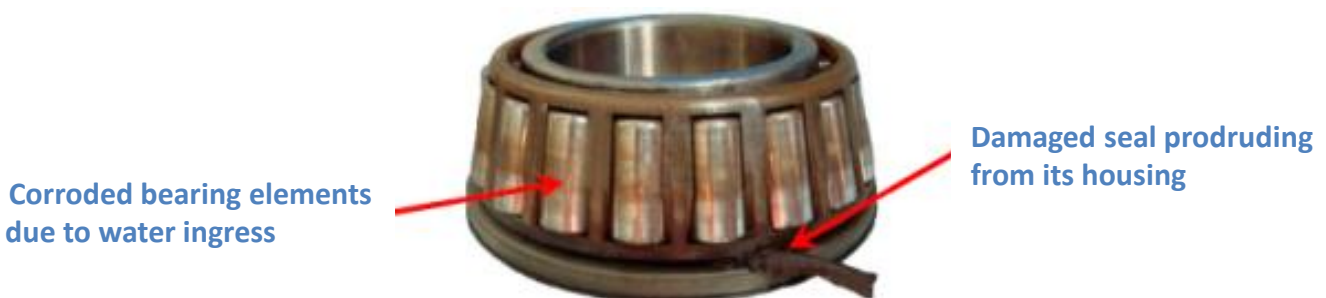
Brake disc hub incorrectly fitted on to the stub axle

During the installation process it is possible to push the brake disc hub on to the stub axle at an angle.

When the brake disc hub is not pushed on squarely there is a possibility that the inner ring of the bearing can be pushed out of its locking ring. When the inner is pushed out of its locking ring damage is normally caused to the seal of the bearing. The damaged seal is unable to keep the grease in and contaminates such as water out.

Lack of grease and contaminants entering the bearing soon allow the bearing to become noisy and fail in a short with in a short amount of time.
