No More Costly Nissan X-Trail Repairs!

Replace MEYLE-HD axle support bushings separately and save money

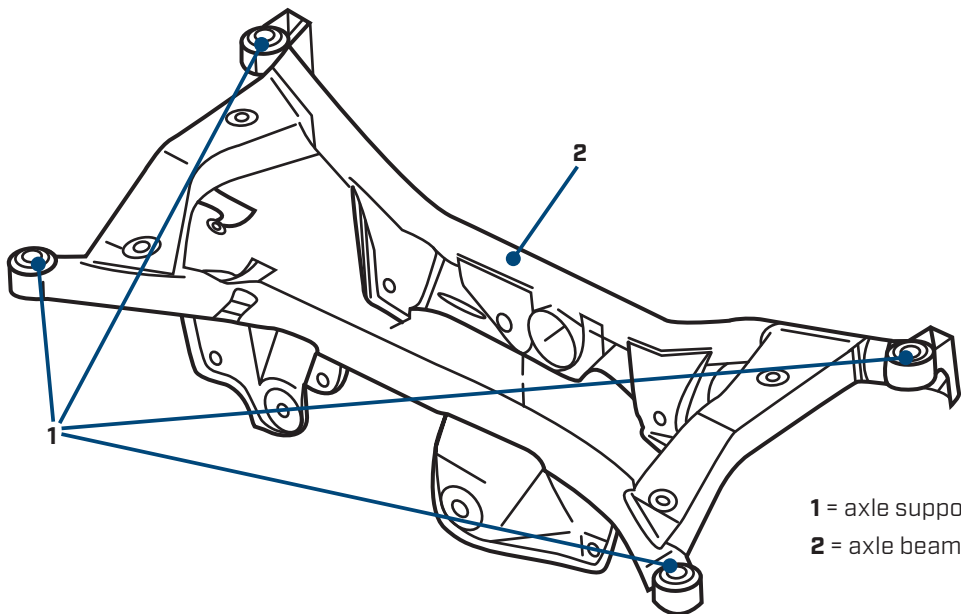
Due to insufficient rubber bonding, the inner sleeve of the original Nissan X-Trail axle support bushing can become loose – a major annoyance to car owners, as the entire axle beam needs to be replaced even though only one bushing requires repair. Original-equipment bushings cannot be replaced individually, making repair a costly affair.

1 = axle support bushings
2 = axle beam

The re-engineered and technically superior MEYLE-HD support bushing features a new material design and a convexly contoured inner sleeve making the MEYLE part very robust and durable. The bushings can be ordered separately or as a kit including four bushings for the entire axle beam.
