SWAG 62 93 6070

Various Citroën, Fiat, Ford, Lancia, Landrover, Mitsubishi and Peugeot models

Part Description: Magnet Wheel for Crankshaft

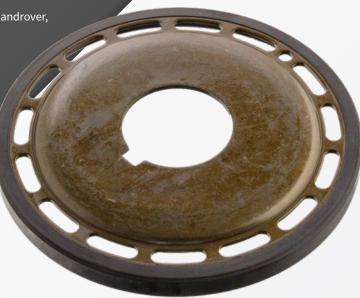
A magnetic reluctor is extremely sensitive to any cleaning or handling. As a result, it may become faulty which can lead to an incorrect crankshaft sensor speed signal. This can result in an engine management malfunction with a fault being logged, such as fault code P0336. (An example of a faulty reluctor with damaged magnetic segments is found above). SWAG recommends replacing the crankshaft magnetic reluctor wheel at the same time as the routine replacement of the timing belt and/or the torsion vibration damper (TVD) pulley.

Example of a faulty reluctor using a magnetic test card

SWAG offers this part singularly or as part of a kit to include the TVD and bolt (62 93 6433 or 62 10 6476). This combination kit enables a professional repair and avoids potential complaints. This saves time and money for both workshop and customer!
