Ford C Max Mk I, Fiesta IV, Focus Mk I, Focus Mk II, Focus C Max, Galaxy III, Mondeo IV, S Max, Courier II, Fiesta Van IV, Transit Connect, Transit Tourneo Connect 1.8TD

FWP 1790

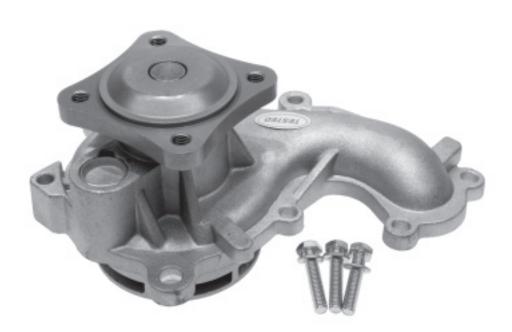
It is imperative to use the bolts that are supplied with this water pump due to changes to the thickness of the pump body.

Failure to use the supplied bolts and in the correct orientation will cause serious damage to the engine block which will be immediately apparent.

It is essential that care is taken when installing the pump as the bolt protrusion can damage the engine block water jacket if they are not located in the correct position.
